# Test Report

Report No.:H202505081935-01EN

Sample Name: SINORA HARD SHELL

Reference  
Document: ISO 20653:2013

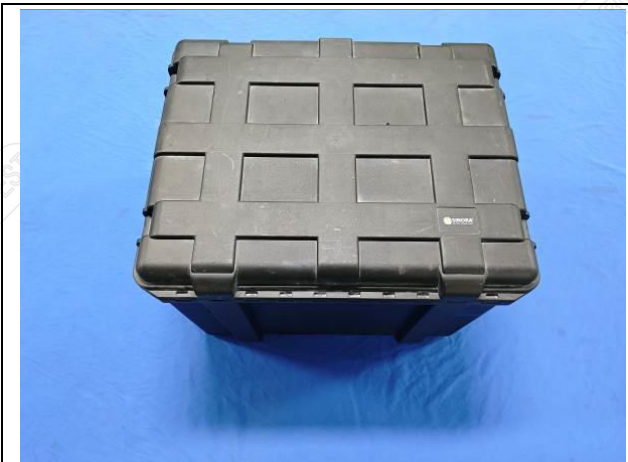
Fig 1-1 Sample before test	Fig 1-2 Sample after the test

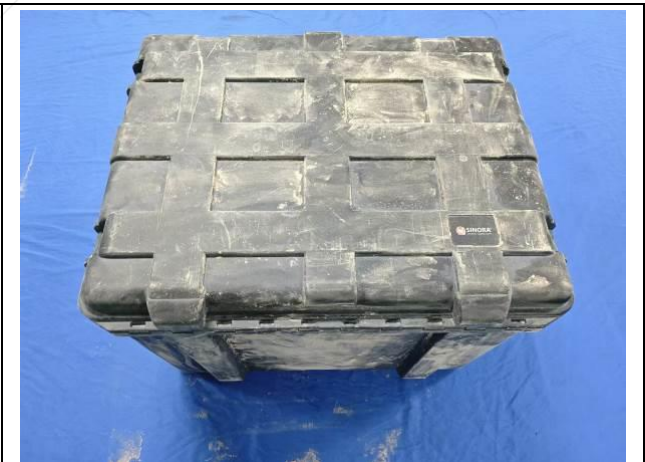
Test No.	Test result	Conclusion
H202505081935-0001	Before the test, the 1mm metal probe did not enter the sample shell. After the test, no dust seeped into the interior of the sample.	Meet the requirements

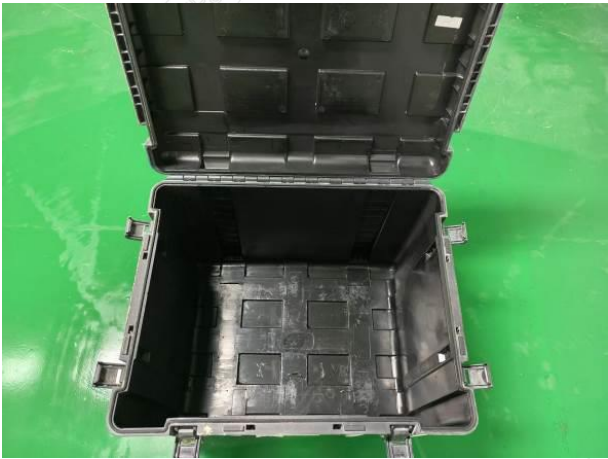
/
Fig 1-5 Internal inspection after the test (no dust entry)	/

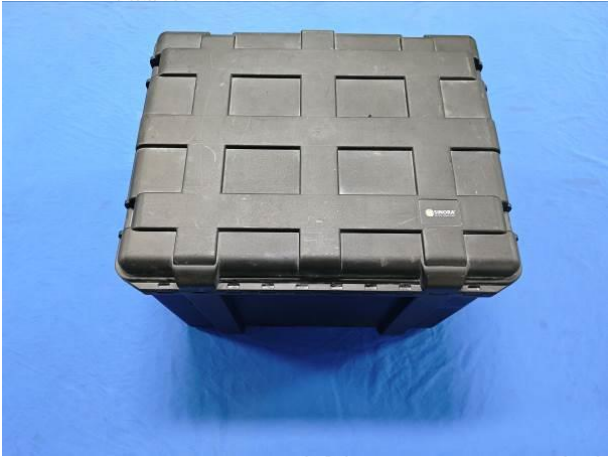
Fig 2-1 Sample before test	Fig 2-2 Sample after the test

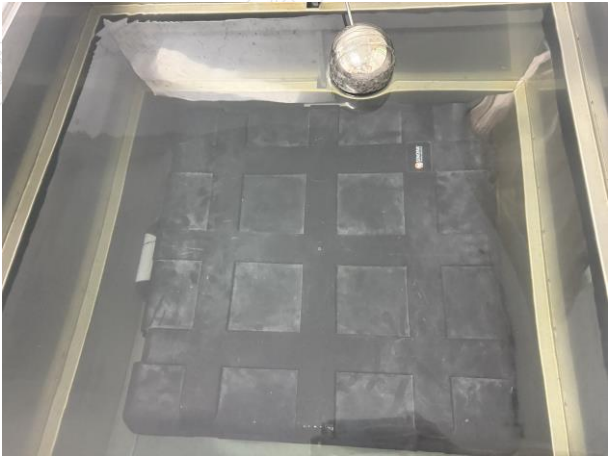
Fix the sample in the immersion pool, with the lowest point of the box at a distance of 1000mm from the water surface. Test duration: 30 minutes.

Fig 2-3 Test setup	Fig 2-4 Internal inspection after the test (no dust entry)

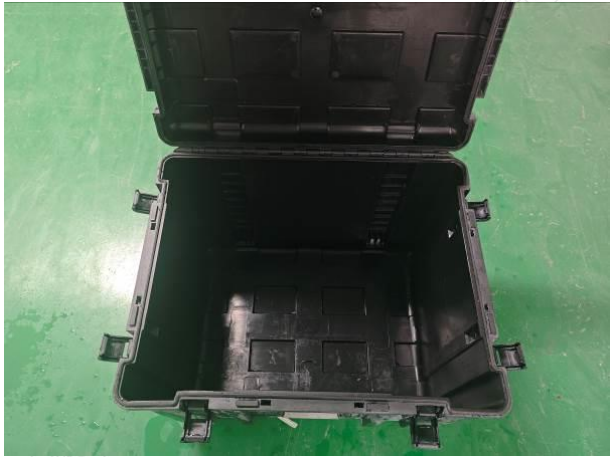
Test No.	Test result	Conclusion
H202505081935-0001	After the test, no water seepage occurred inside the sample.	Meet the requirements
